DESIGN, DURABILITY AND LOW-COST PROCESSING TECHNOLOGY FOR COMPOSITE FAN EXIT GUIDE VANES

by S. S. Blecherman

UNITED TECHNOLOGIES CORPORATION
Pratt & Whitney Aircraft Group
Commercial Products Division

National Aeronautics and Space Administration NASA Lewis Research Center Contract NAS3-21037

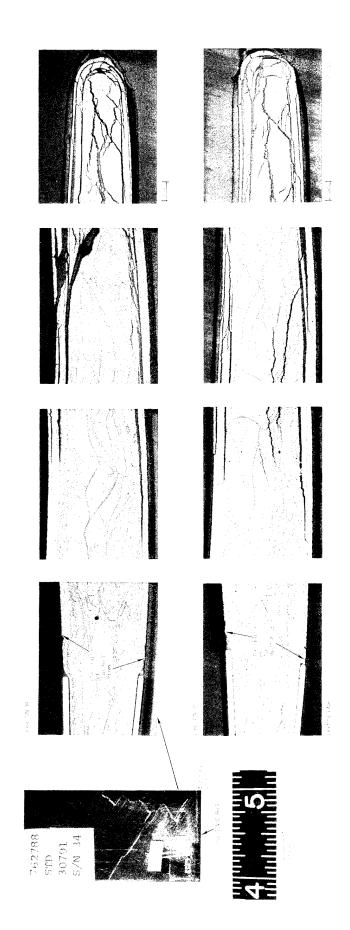
Photomicrograph of Graphite/Epoxy Fan Exit Guide Vane Fatigue Failure Figure 5-28
